Destructive Single-Event Effects in Diodes

Megan C. Casey¹, Jean-Marie Lauenstein¹,
Michael J. Campola¹, Edward P. Wilcox², Anthony M. Phan²,
and Kenneth A. LaBel¹

¹NASA Goddard Space Flight Center

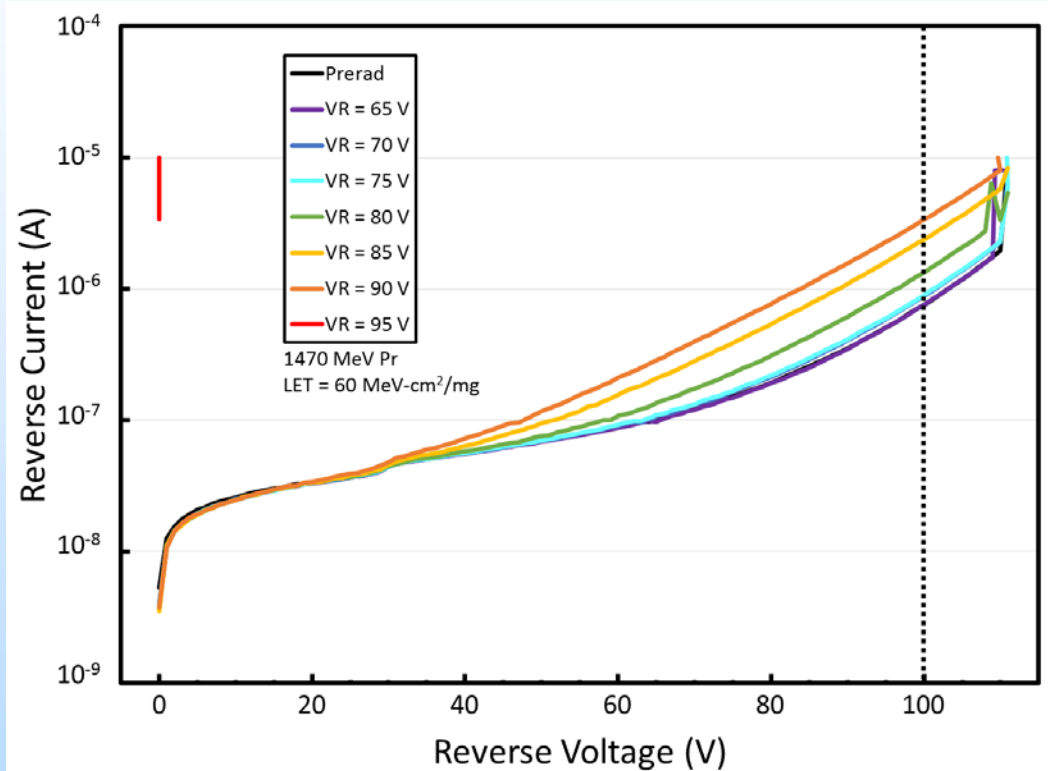
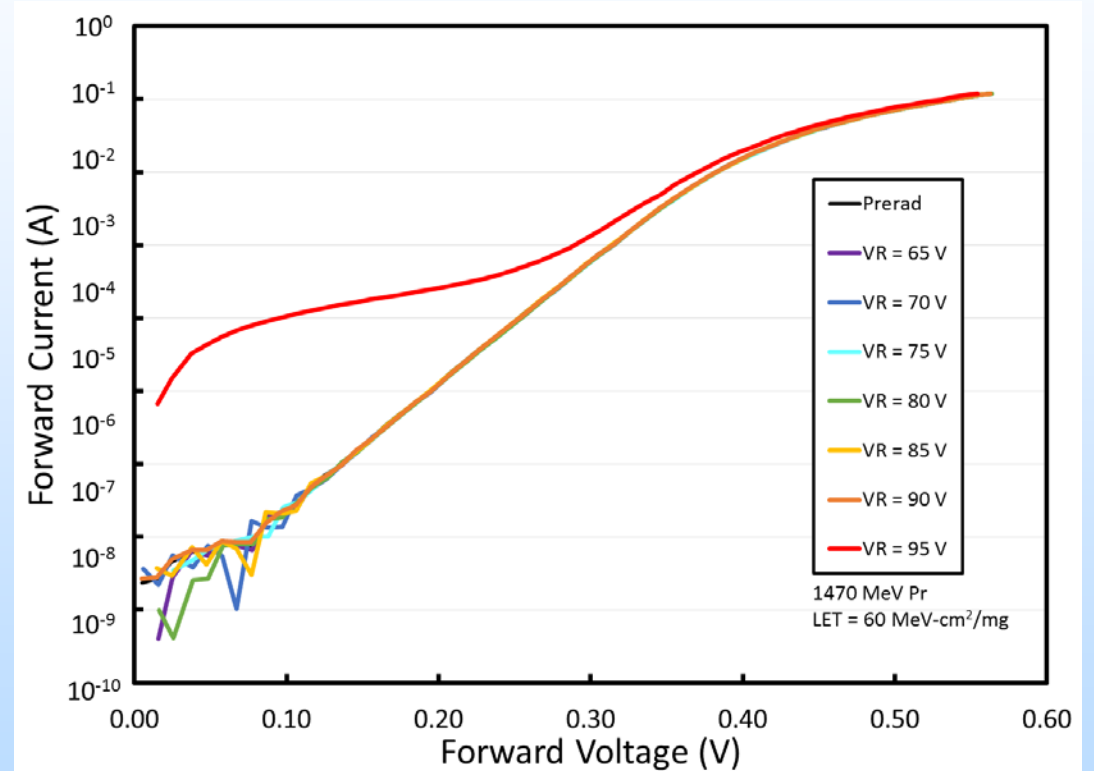
Part was degrading until after the 95-V run, and then I_R exceeded 10 μ A at less than 1 V

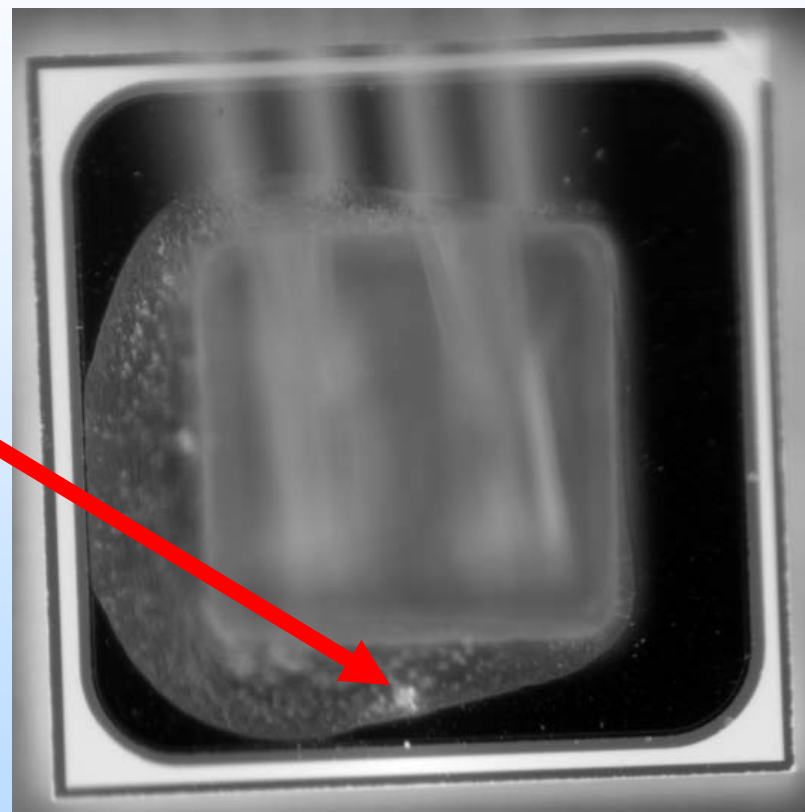
Infrared Imaging of DUT

- Diode was examined using an IR camera and pictures were taken with a small voltage applied
 - Bright white spot just below the wirebond contact is the location of the failure
- Low-magnitude and high-magnitude optical images of the surface of the DUT did not show anything unusual at the location identified in the IR image

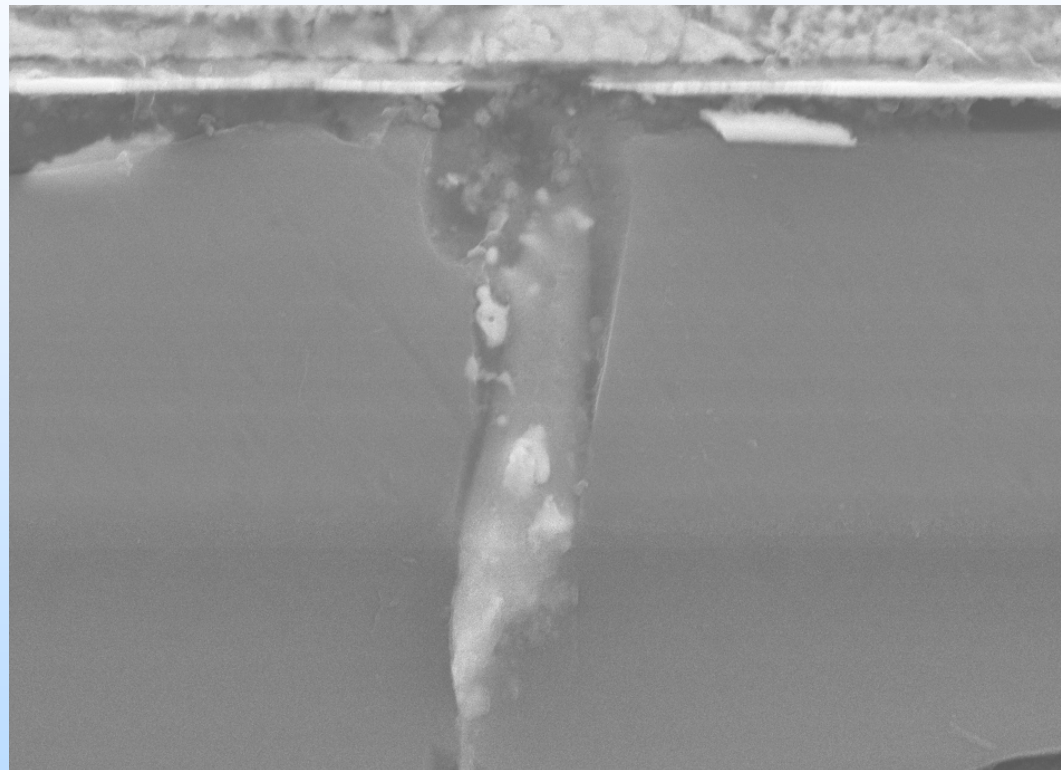
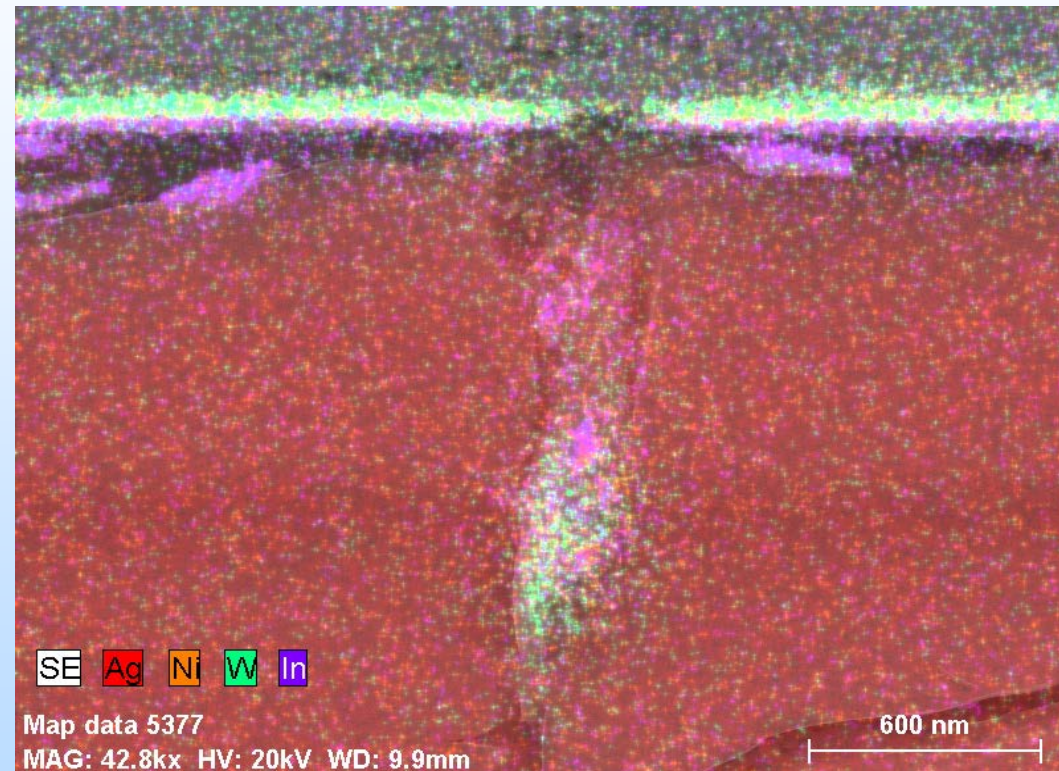
Metal has clearly displaced from Schottky junction into void
formed from high current

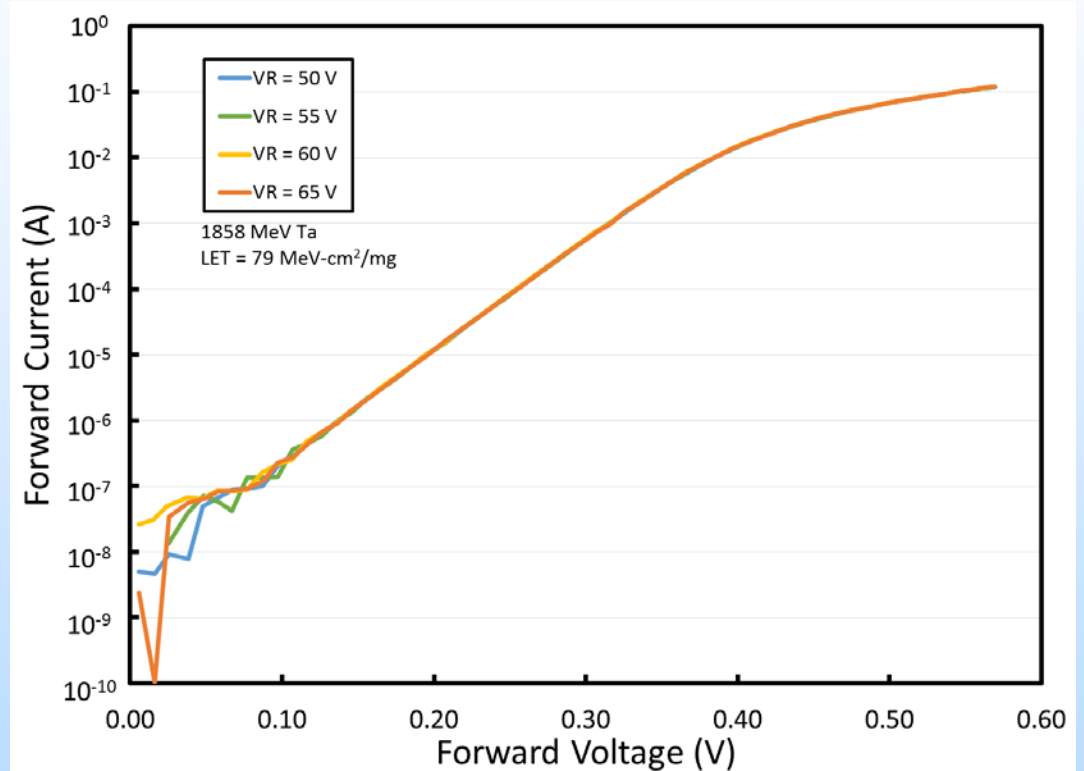
No significant changes were observed in the I_F - V_F curves, but I_R exceeded specification at less than 100 V

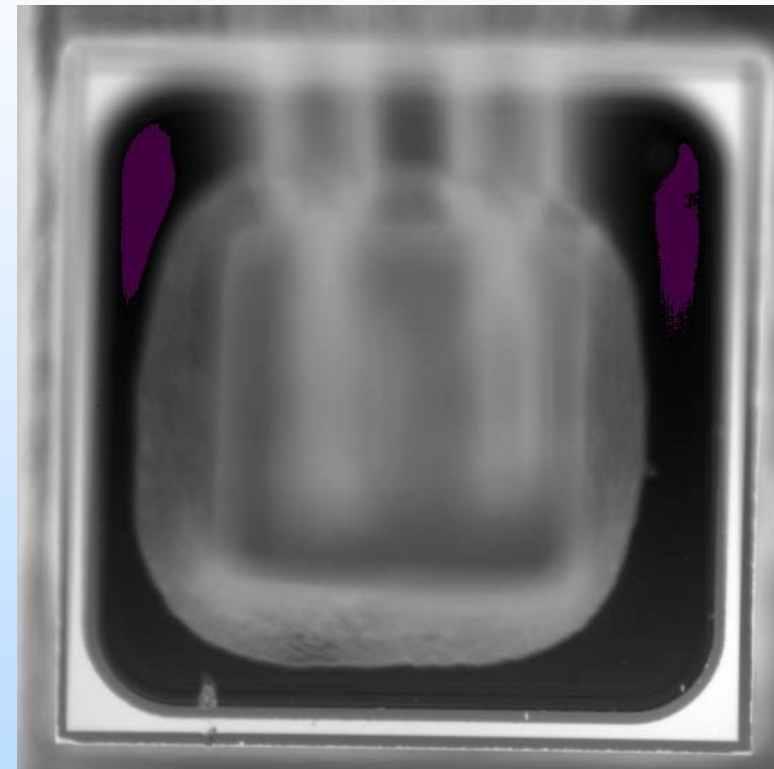
Infrared Imaging of DUT

- Diode was examined using an IR camera and pictures were taken with a small voltage applied
 - No failure locations could be identified
- Low-magnitude and high-magnitude optical images of the surface of the DUT also did not show anything unusual
- Because no failure locations were identified, a different technique had to be used
 - A series of chemical etches were used to remove the contact pad, solder connection, and Schottky barrier metal

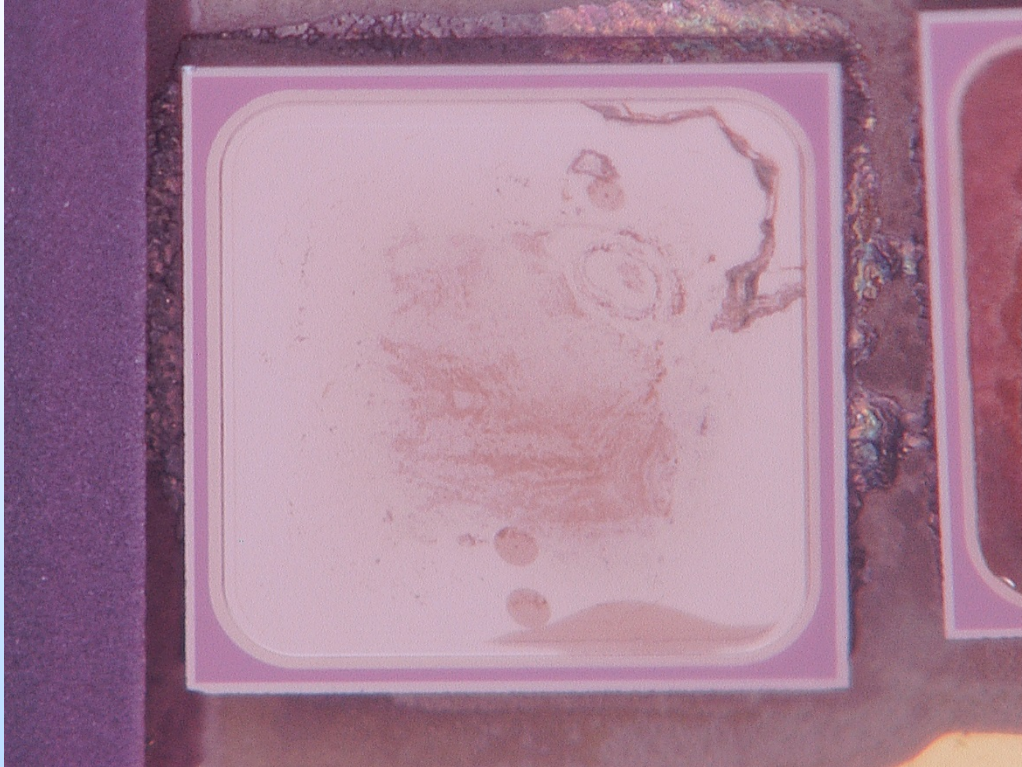
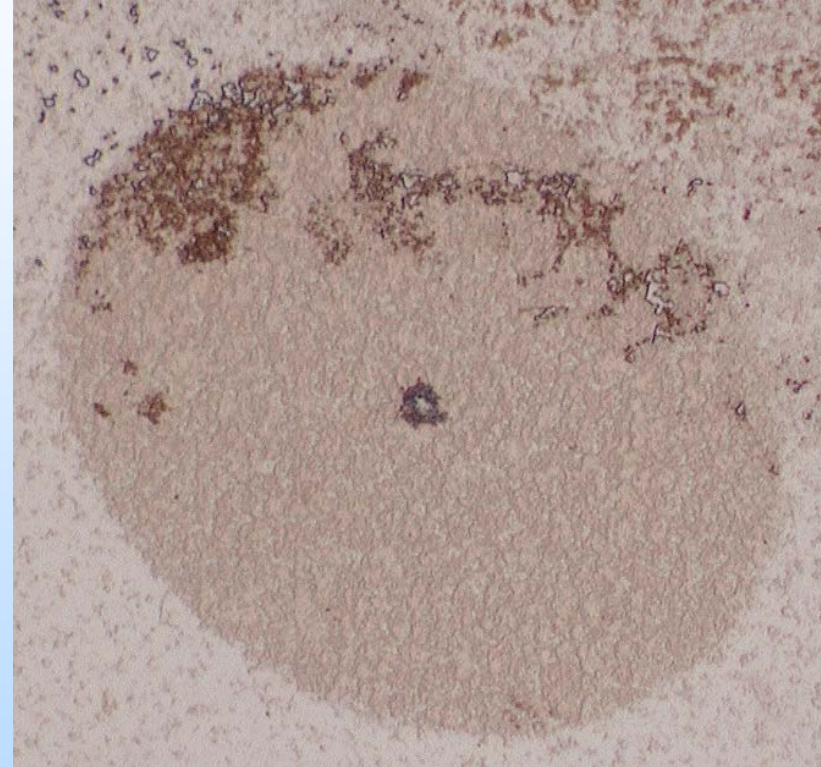
After chemical etches, a few small discolored locations were identified with displaced silicon at the center

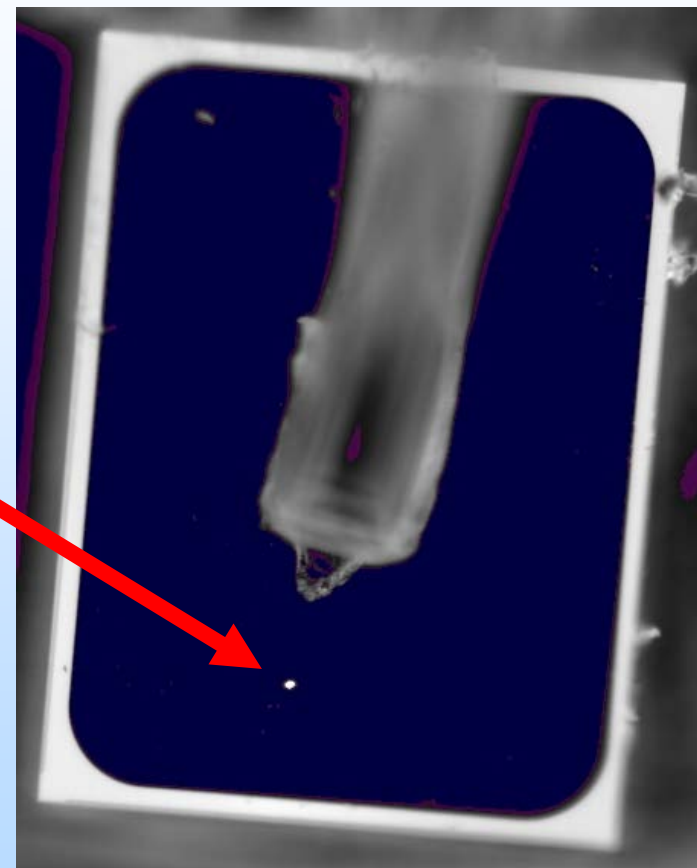
Infrared Imaging of DUT

- Diode was examined using an IR camera and pictures were taken with a small voltage applied
 - Bright white spot just below the wirebond contact is the location of the failure
- Low-magnitude and high-magnitude optical images of the surface of the DUT did not show anything unusual at the location identified in the IR image

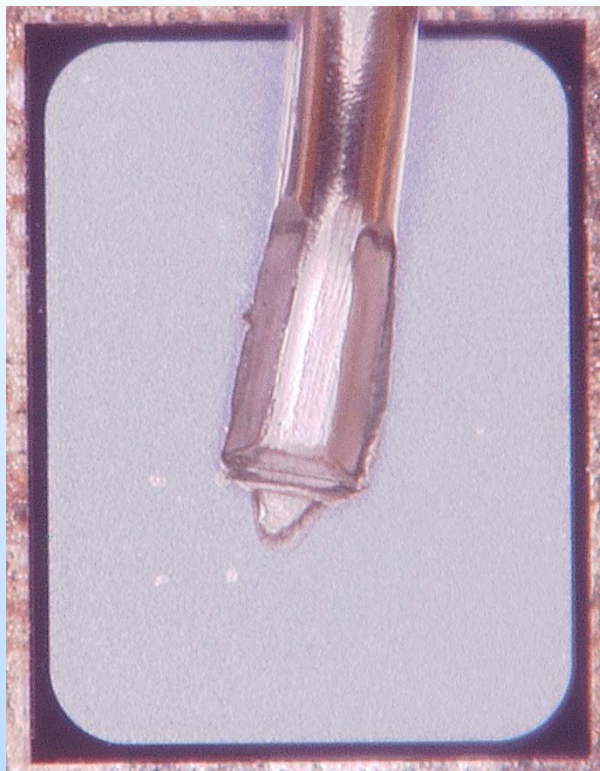
Unlike other part that experienced catastrophic failure,
location is visible in high-magnification optical images

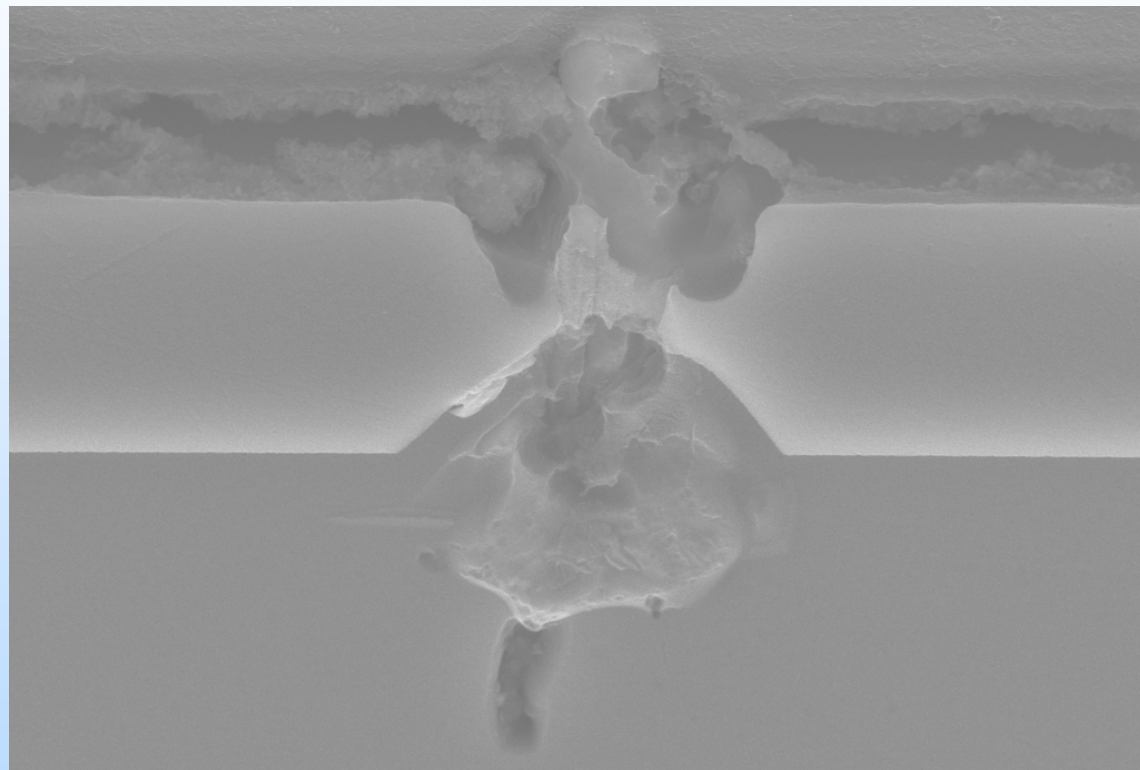
Metal has clearly displaced from Schottky junction into void
formed from high current

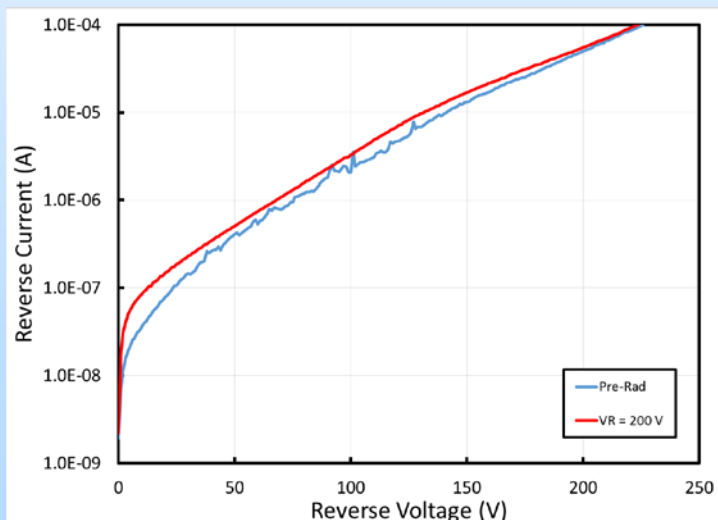
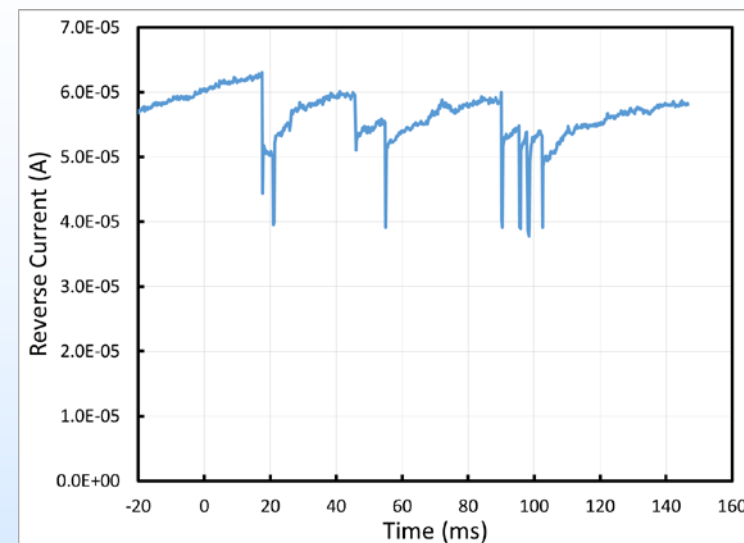
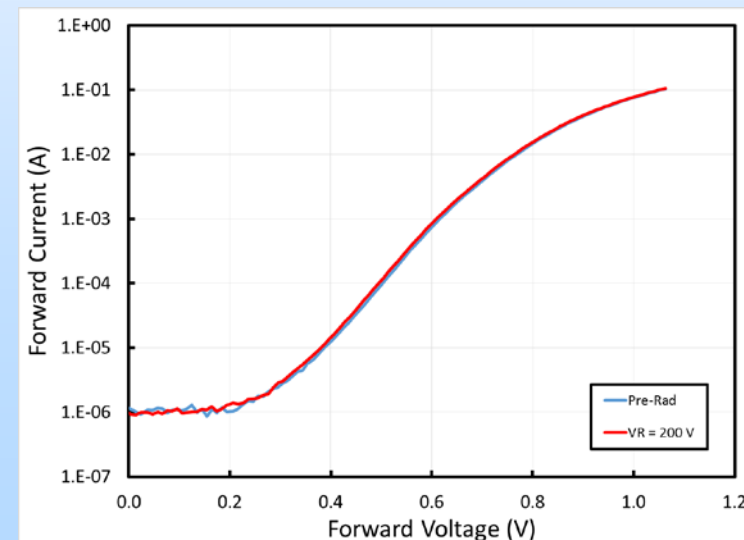
Diodes, Inc. BAS21-7-F Switching Diode

- Small changes in the reverse current were observed during the runs in which these parts were biased at the full-rated 200-V reverse voltage
- Small changes in the I_R - V_R and I_F - V_F plots were observed after the runs
 - How these changes effect the long-term reliability of the parts is unknown
